Installation and Service Instructions for 1-056-X00* Series (all revisions) Manual Adjust Brakes

*This sheet includes Series 1-056,000; 1-056,100; 1-056,200; 1-056,300; 1-056,400; 1-056,500; 1-056,600 and 1-056,900. For other series consult factory.

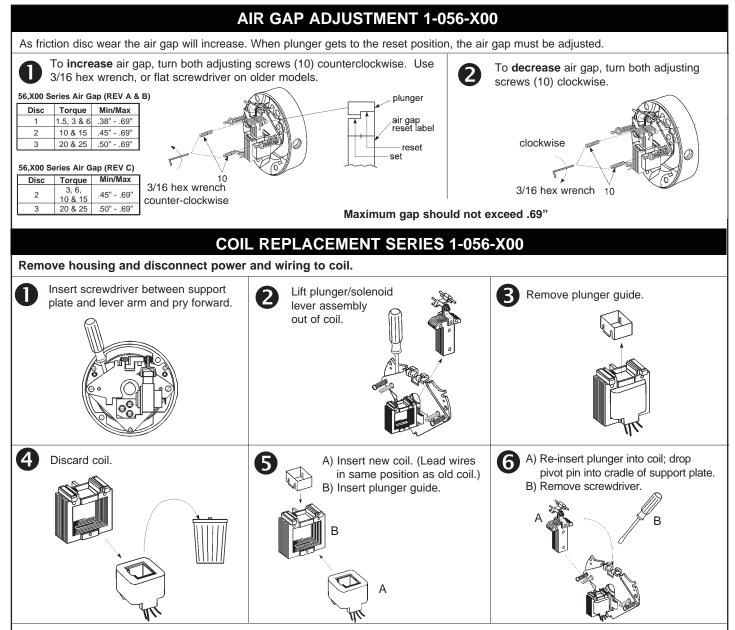
VERTICAL SPRING ASSEMBLY 1-056-X00

Reconnect coil and replace housing per installation instructions, page 2.

factory assembled for horizontal operation.) Remove support plate by loosening the three mounting screws.
